## **MICROWAVE PATH SURVEY REPORT**

### **RADIO FREQUENCY INTERFERENCE (RFI) MEASUREMENT REPORT**

ViaSat

Reno, NV (Truckee, CA)

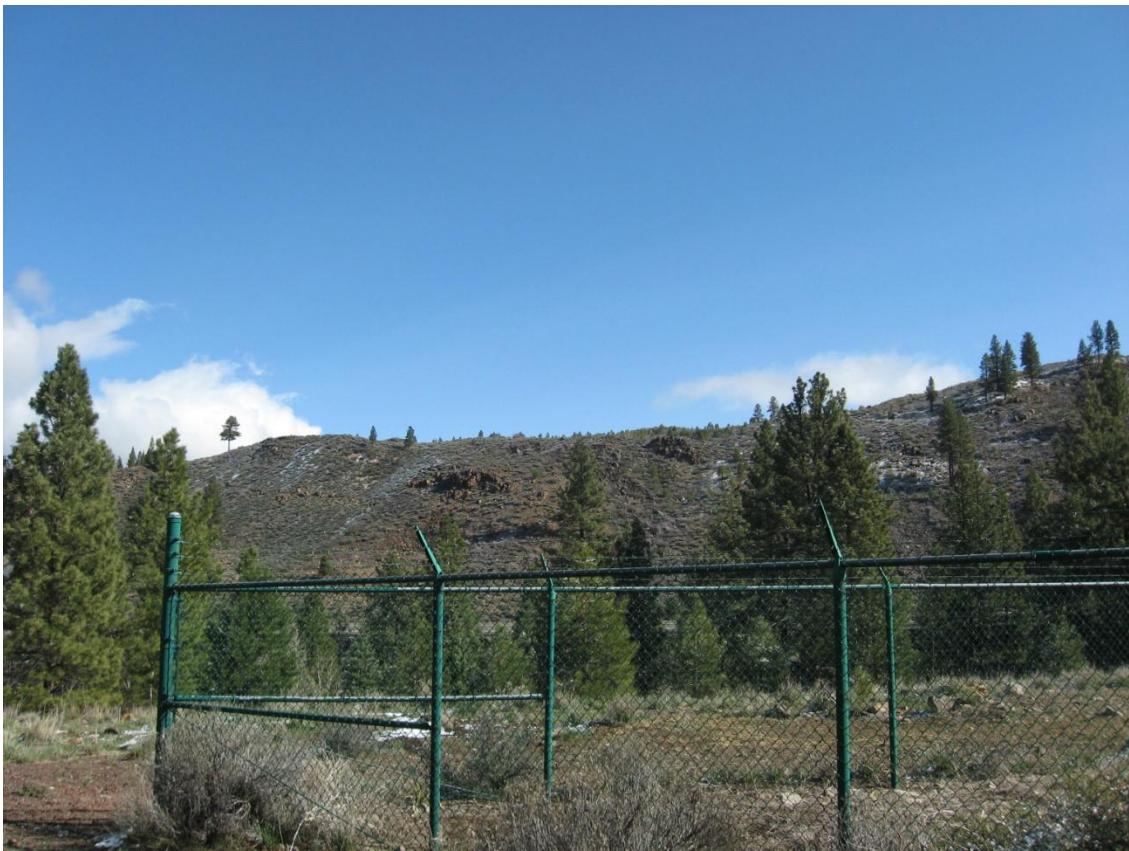
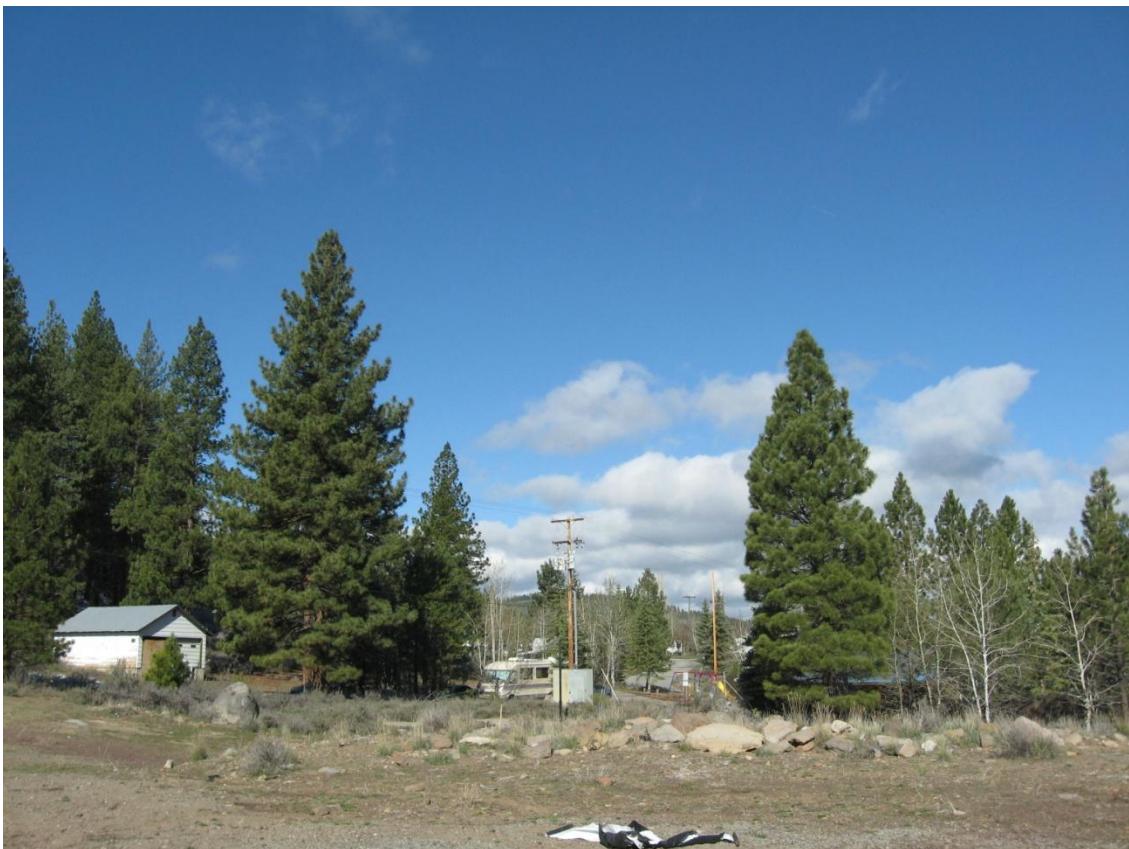
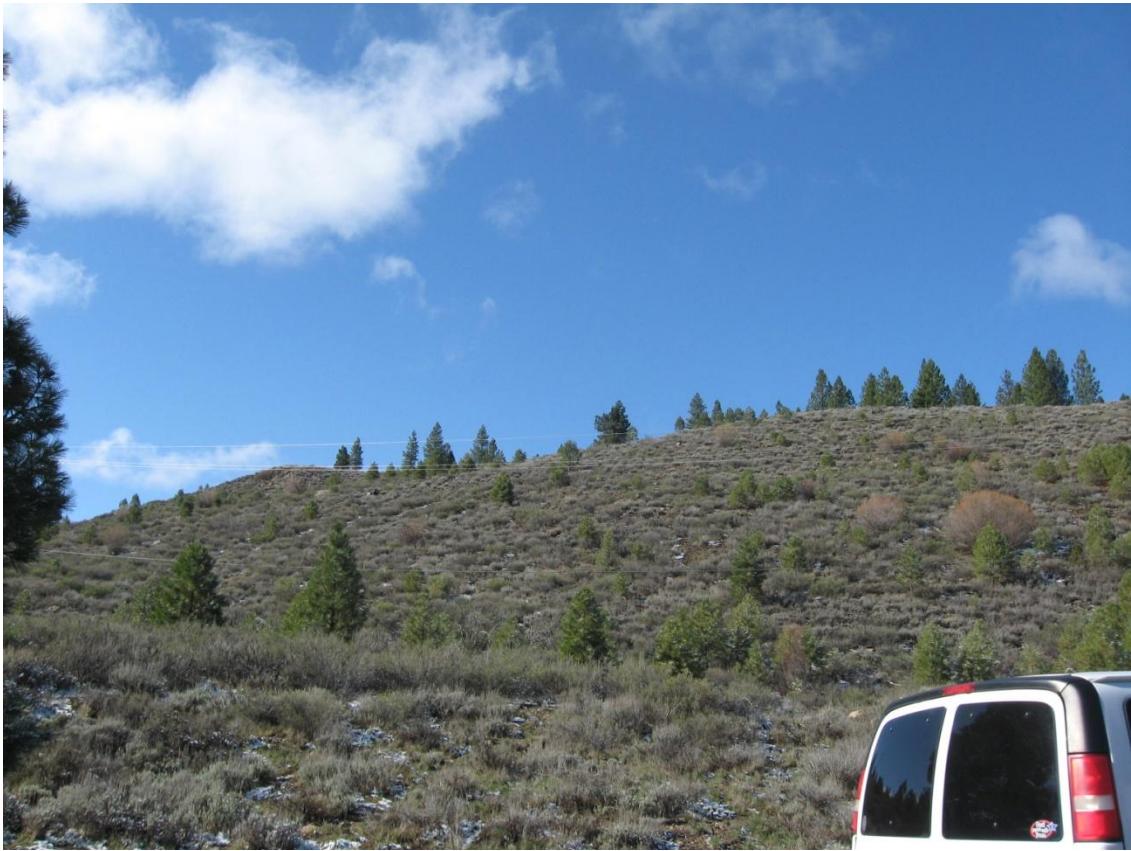
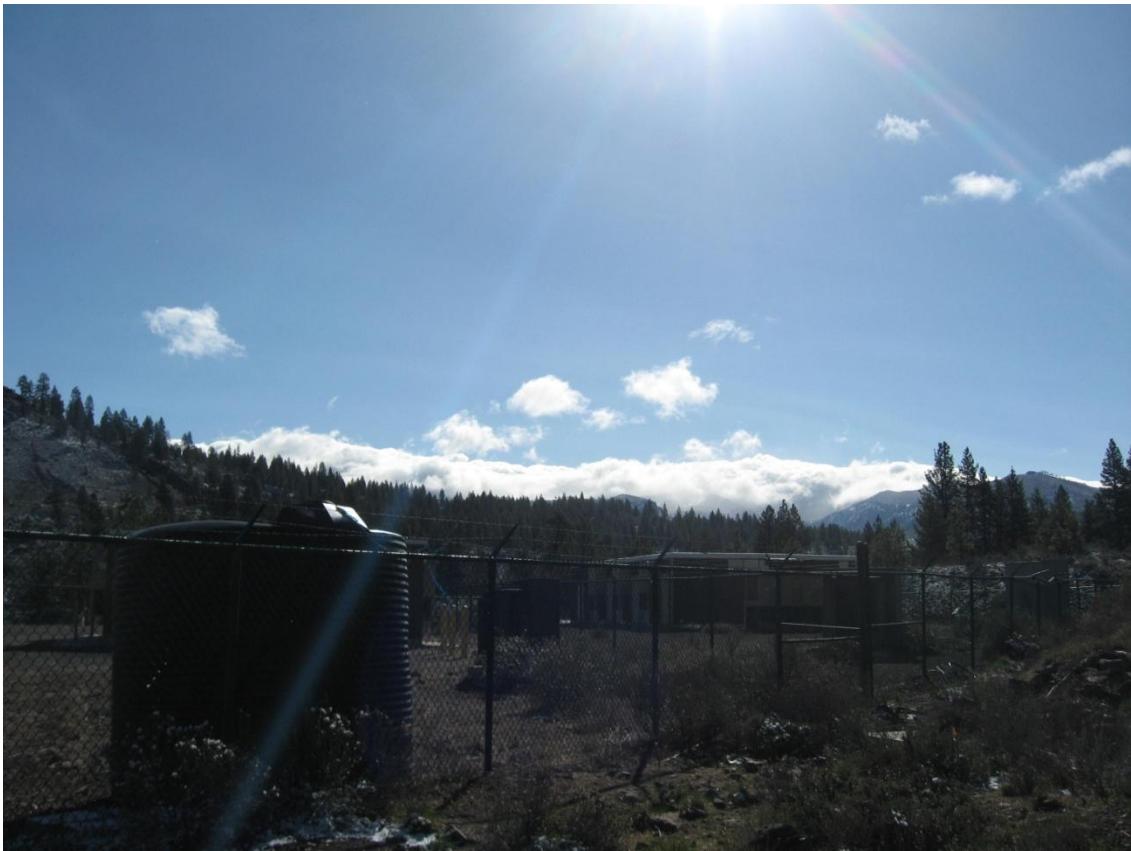
Figure 3.1-1 Earth Station Site Photographs

- Table 3.1-1 presents a site data sheet including all pertinent site information.
- Figures 3.1-1 and 3.1-2 are the photographs depicting the existing earth station site and satellite arc.
- Figures 3.1-3 through 3.1-10 are the RF spectrum photographs depicting the interference environment at the test site.

There is no potential satellite arc blockage at this site. Final arc clearance will depend on antenna placement.

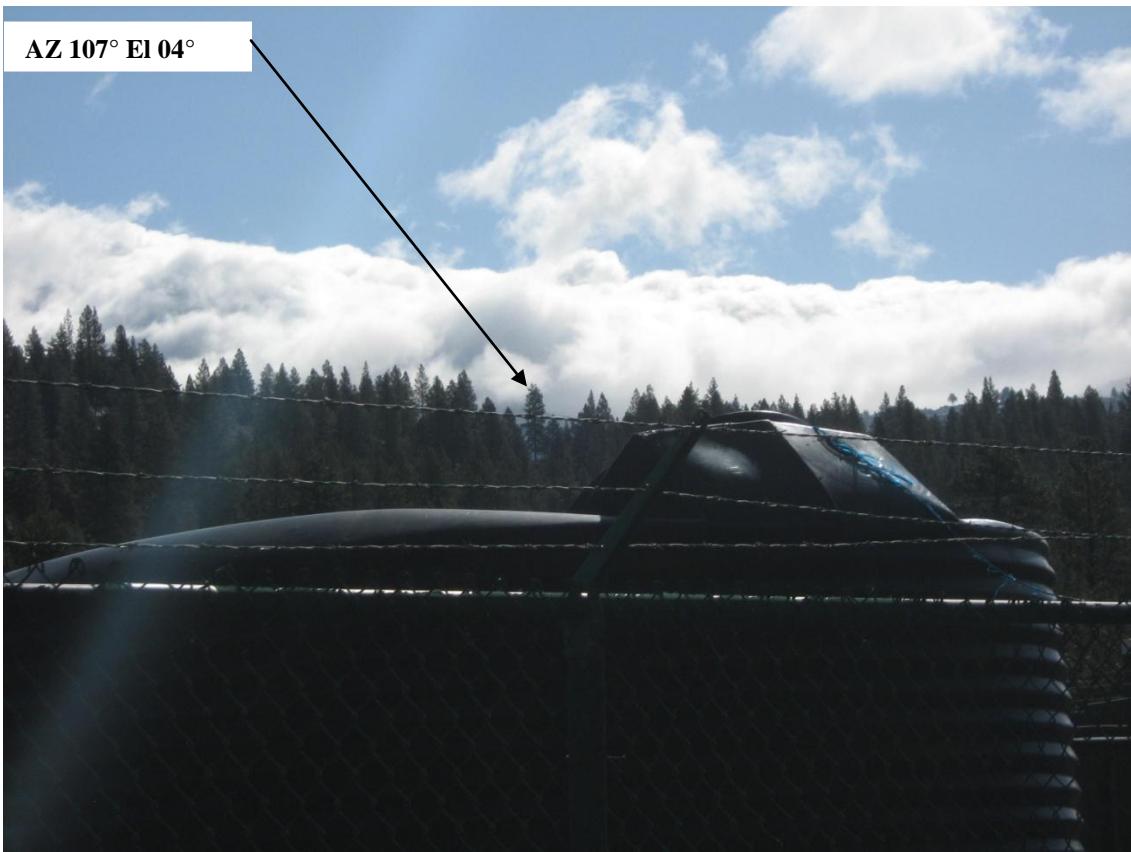
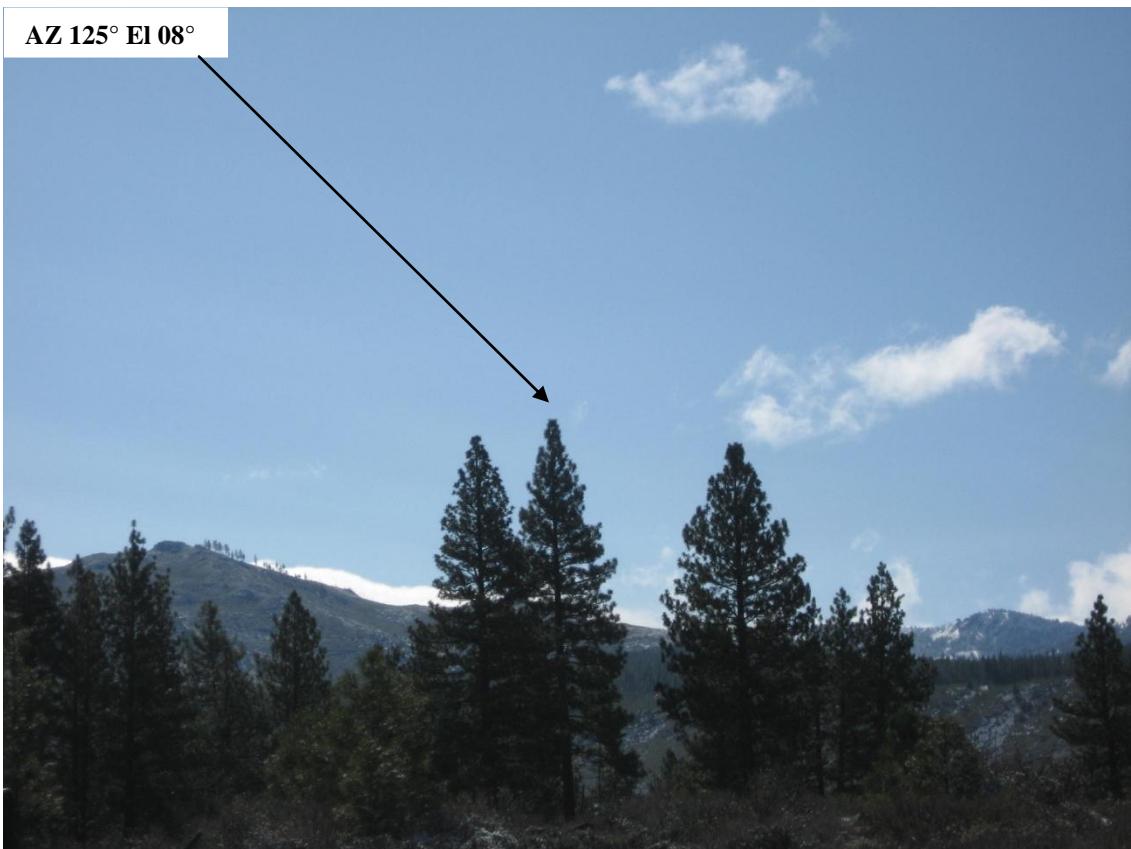
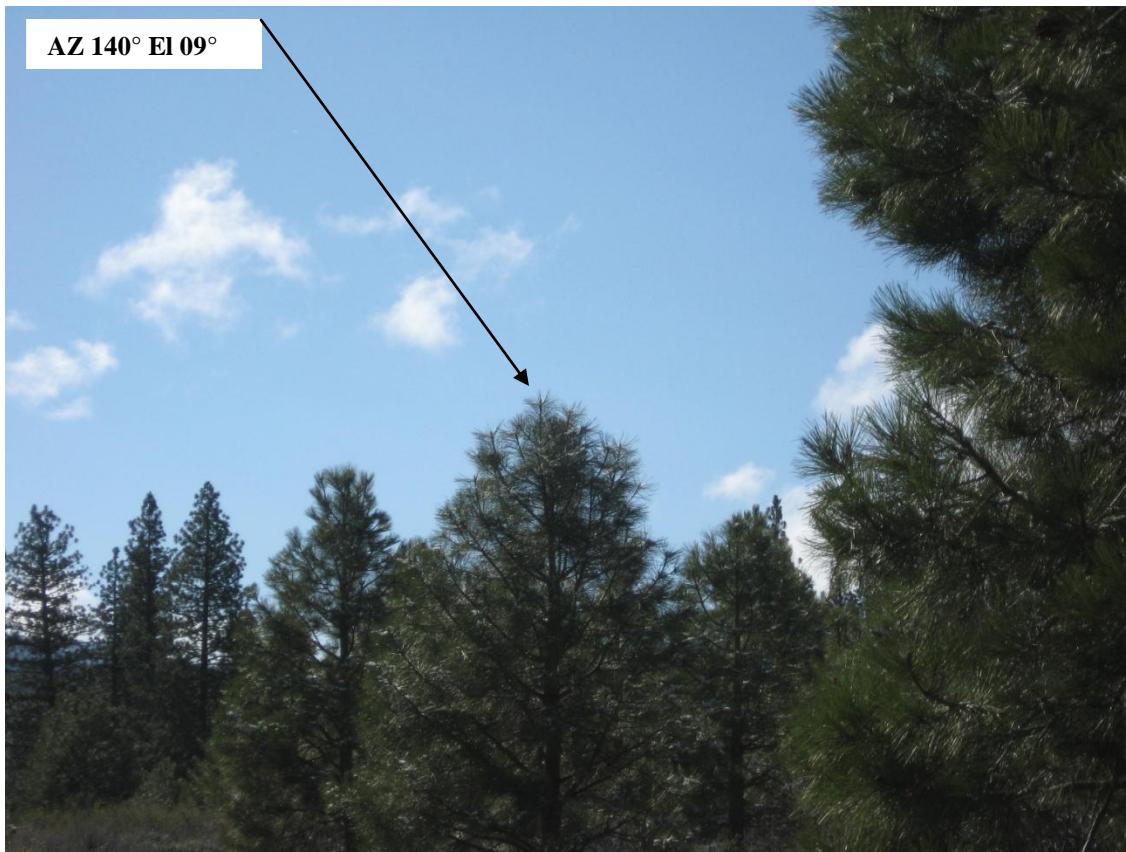
Figure 3.1-2 Horizon Photographs of Earth Station Site

The satellite arc has no potential blockage from 55W through 115W.
